APPENDIX B: FIELD SITE ASSESSMENTS

4-Stream, 3165 BUFFALO RD, -77.117102, 39.488838

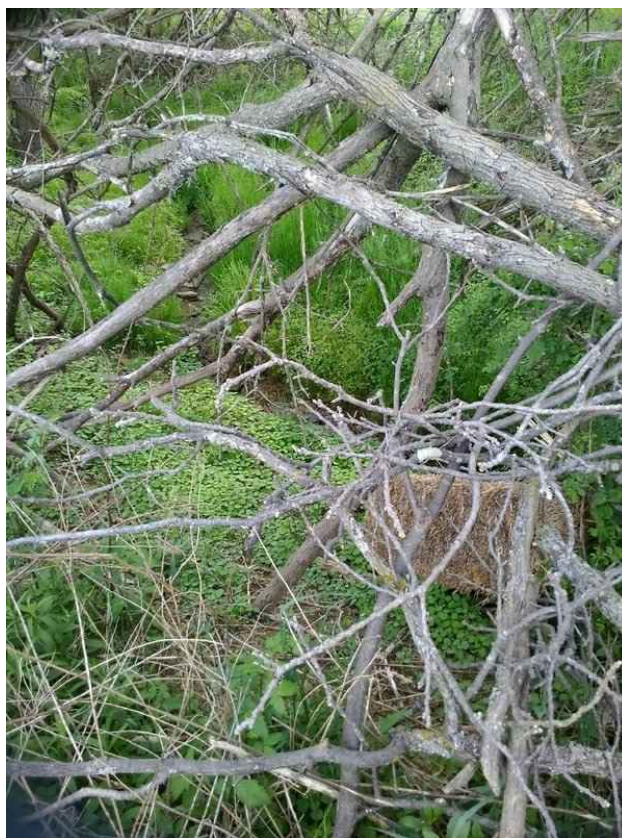
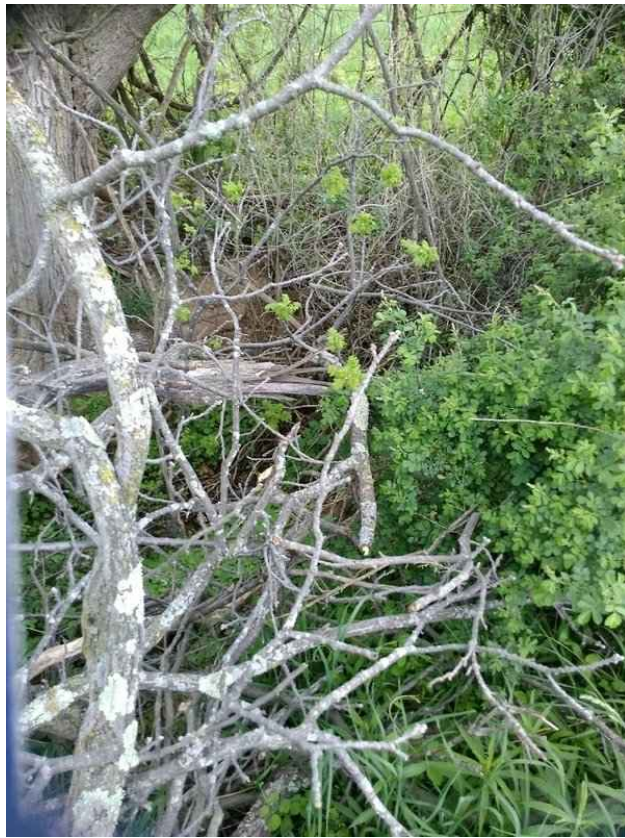
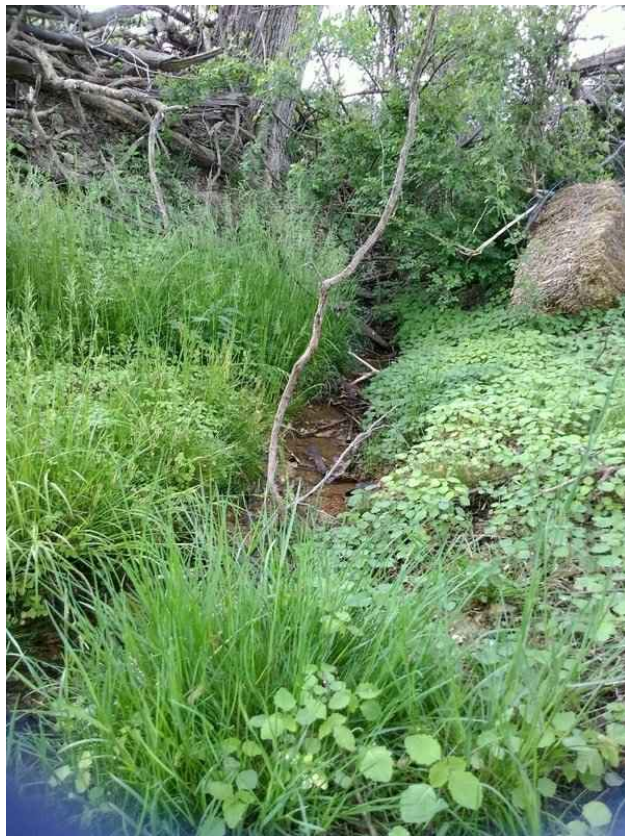
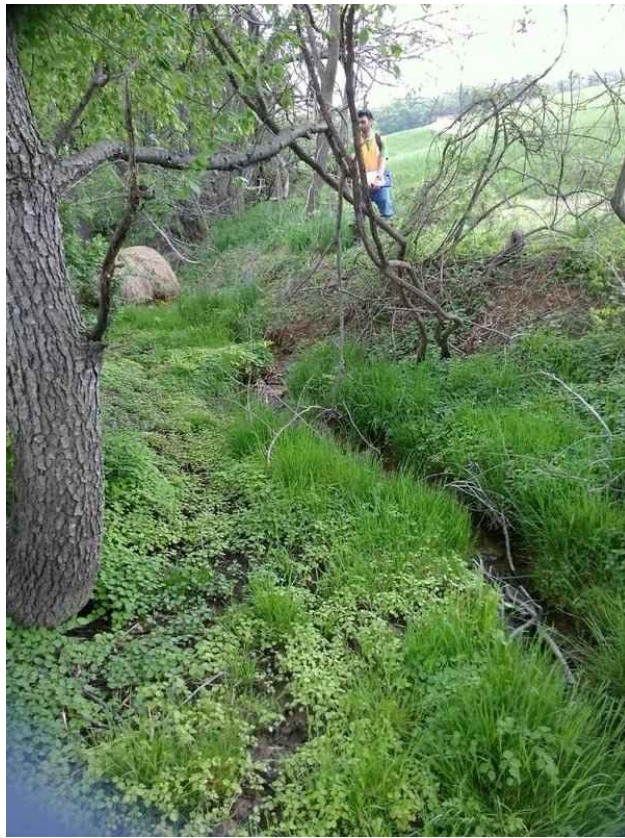
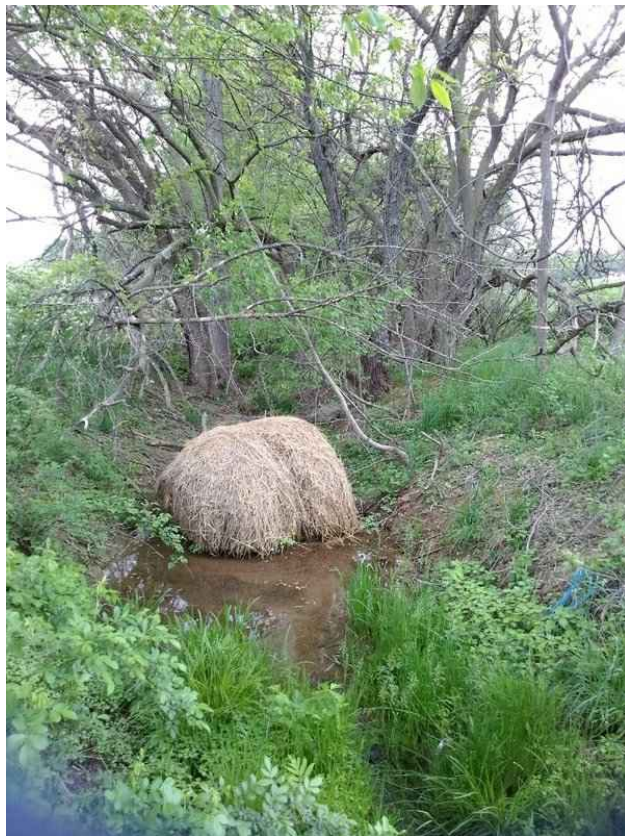
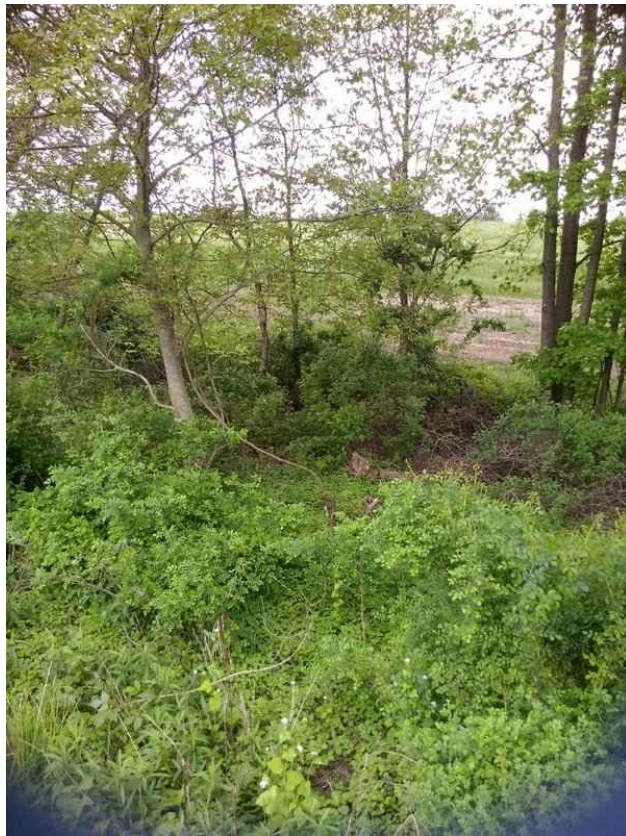
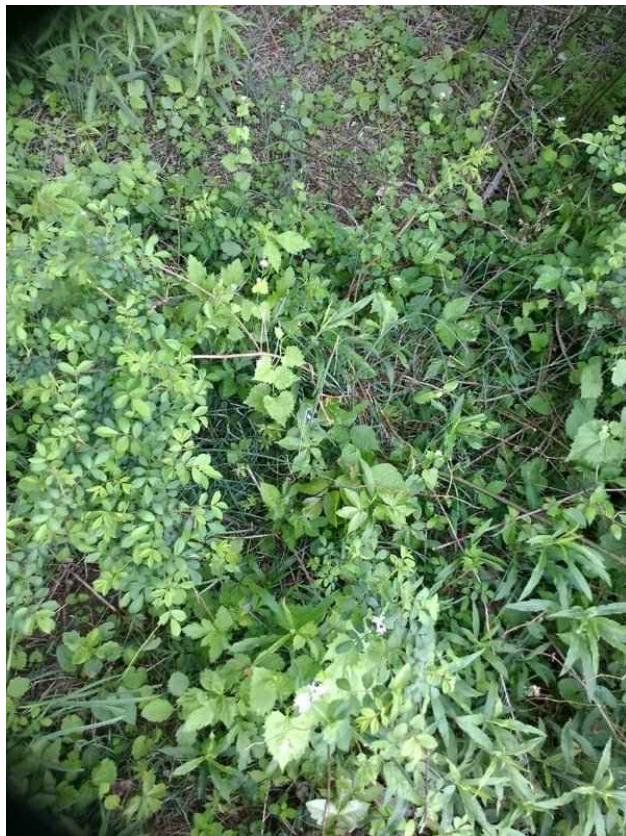
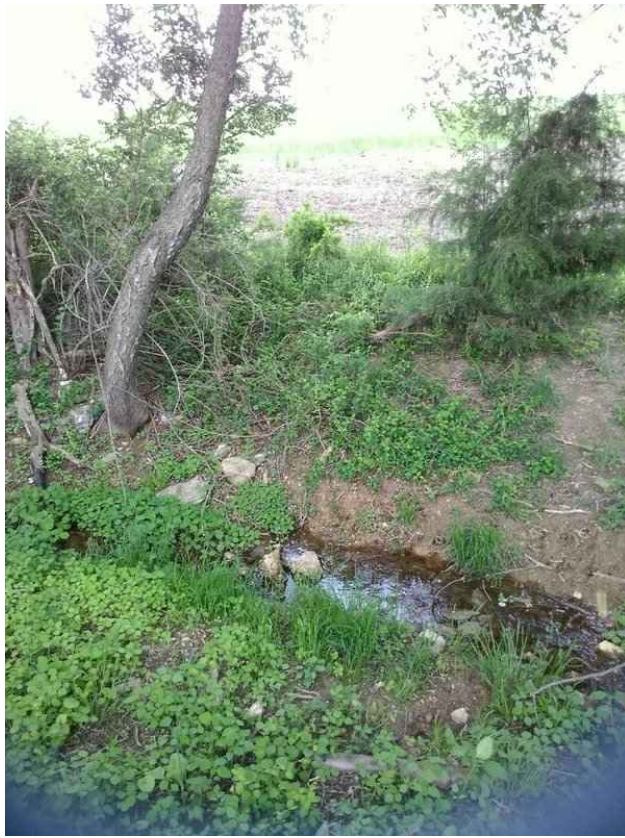
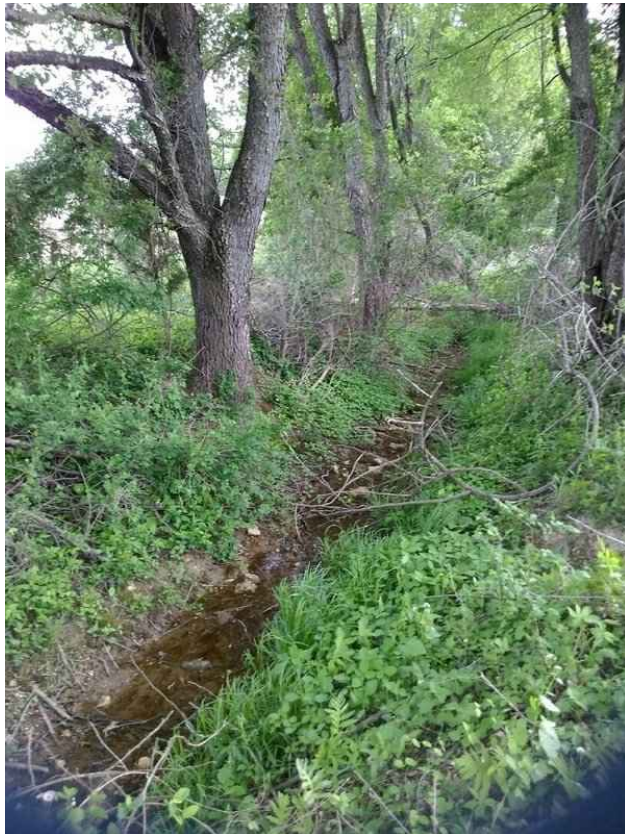
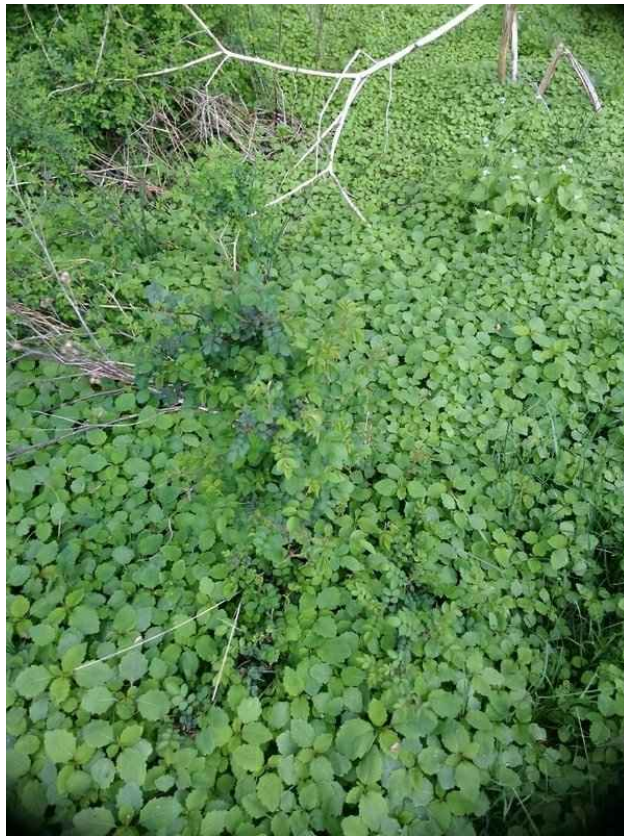
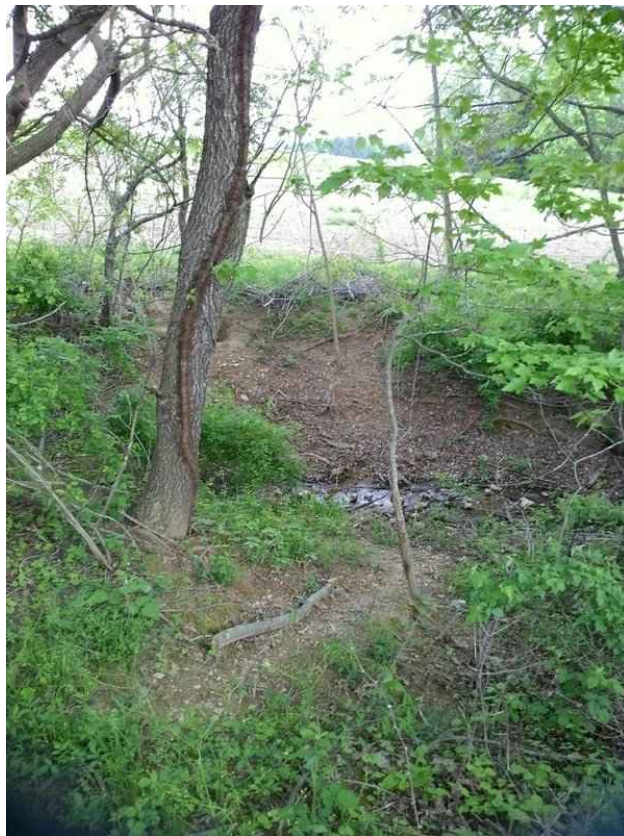
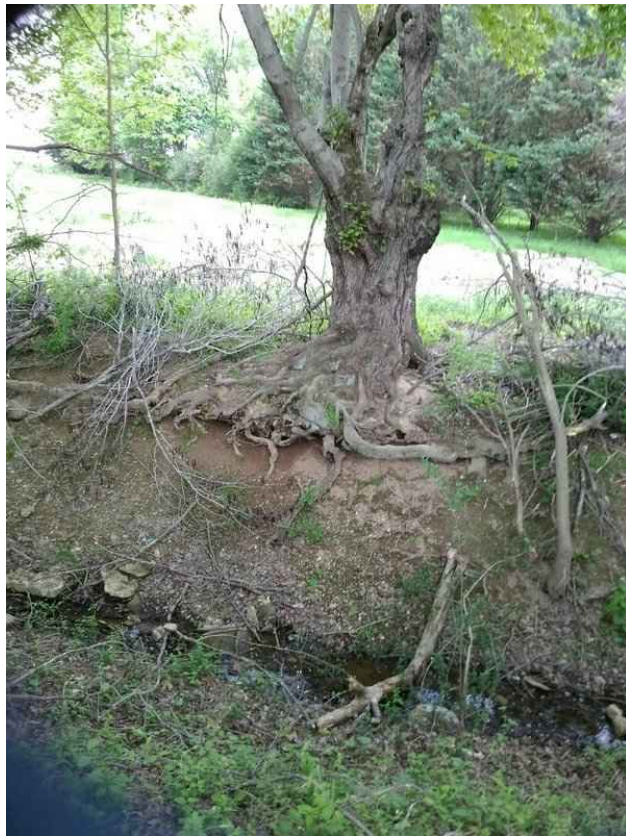
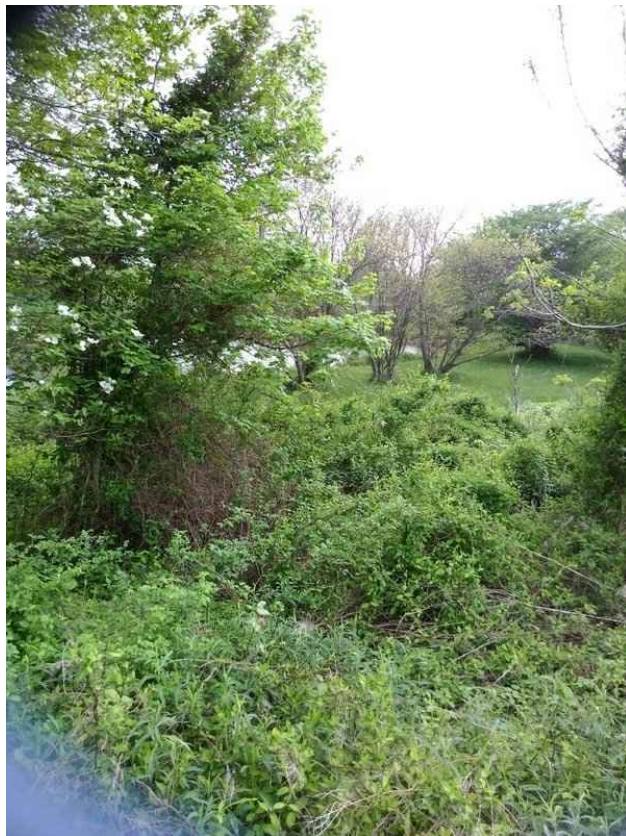
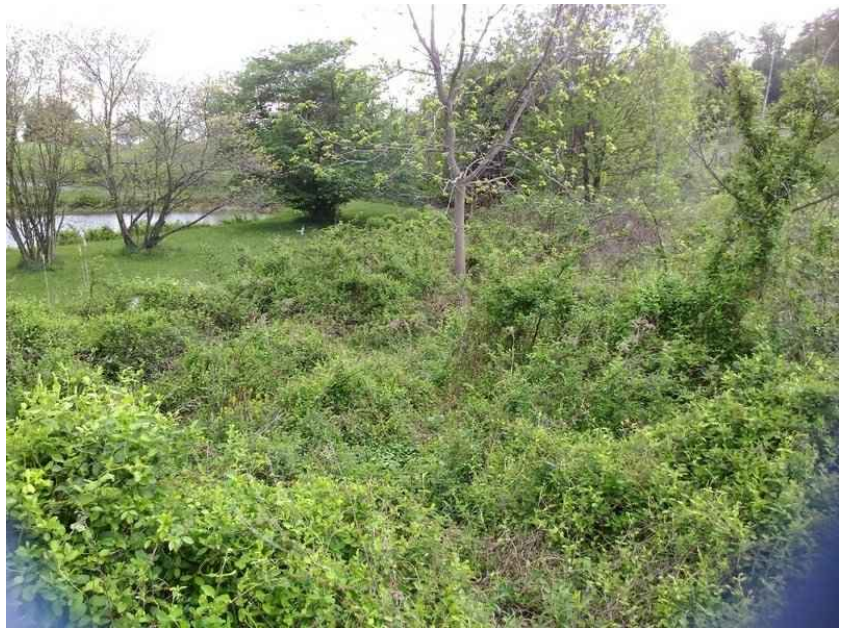
Photos

| Reach Setting | Headwaters stream. Reach starts and ends in brush/forest area, on edge of forested area on left and grassed field on right |
| Vertical Confinement | Culverts, built stone cascade d/s of culvert |
| Vertical Adjustments | Headcuts, woody debris jam w/aggregation u/s of it, d/s of headcut |

| Restoration Ideas | Floodplain reconnection, culvert replacement, grade control at headcut and wd jam, invasive mgmt, riparian restoration |

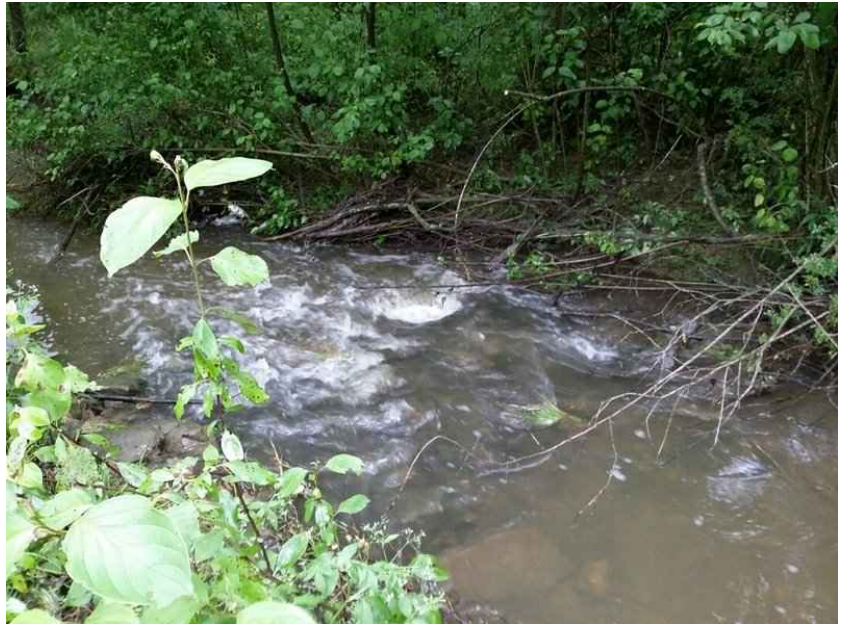
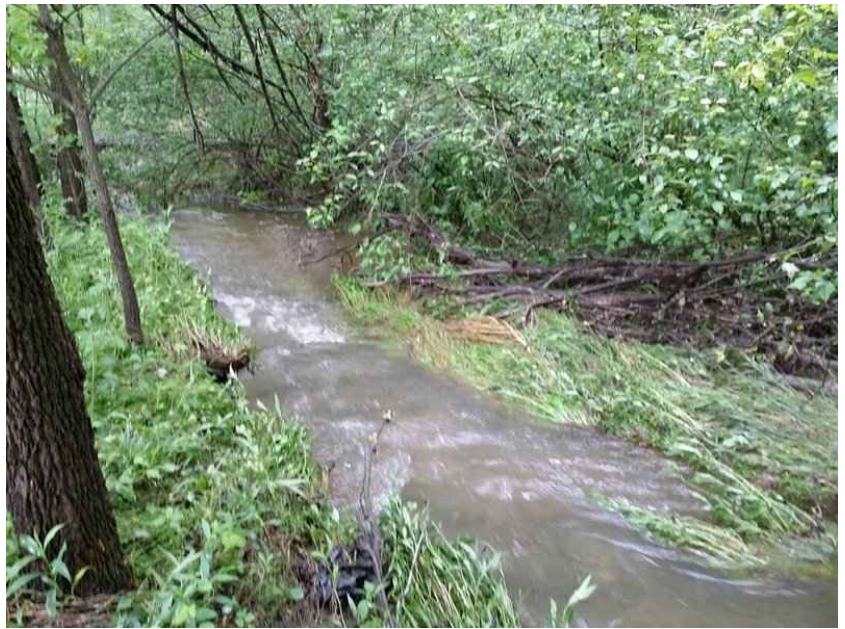
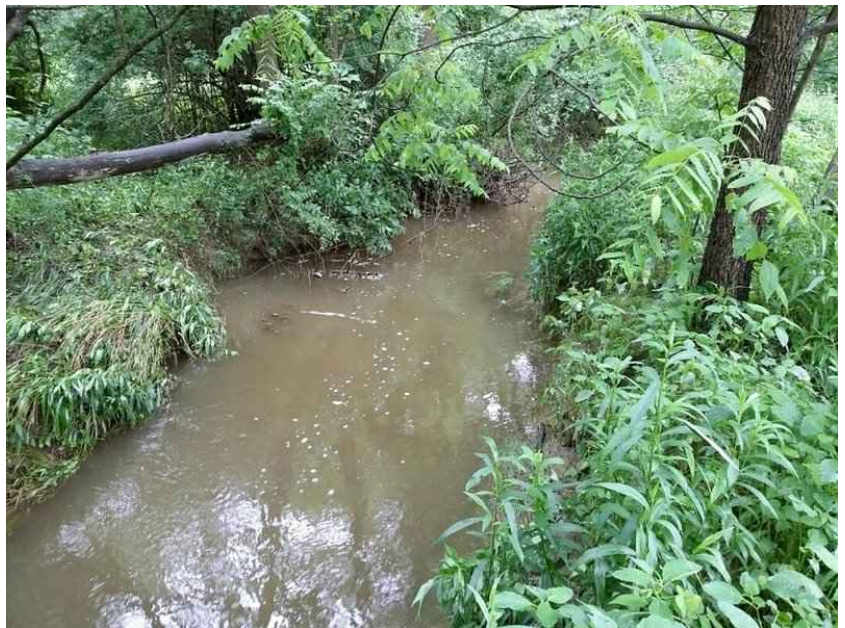
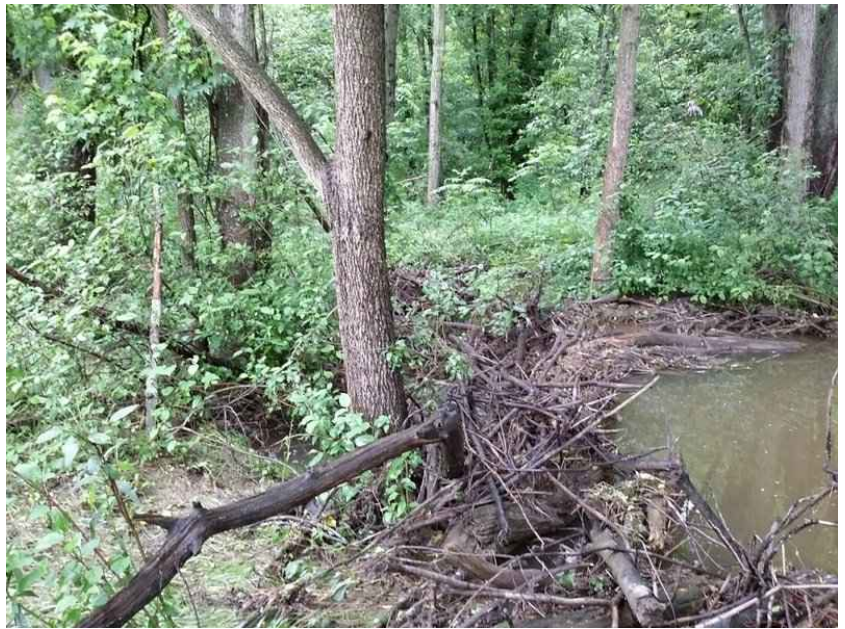
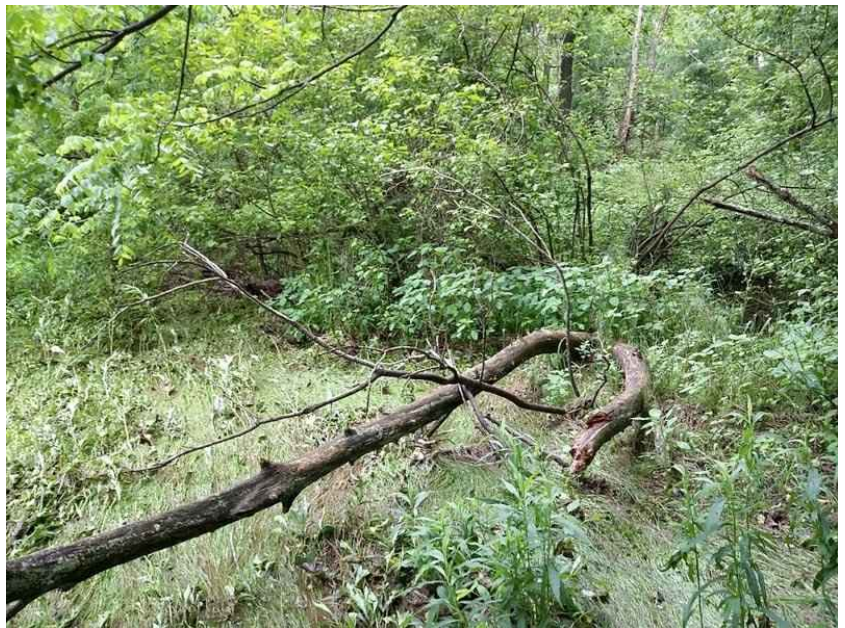
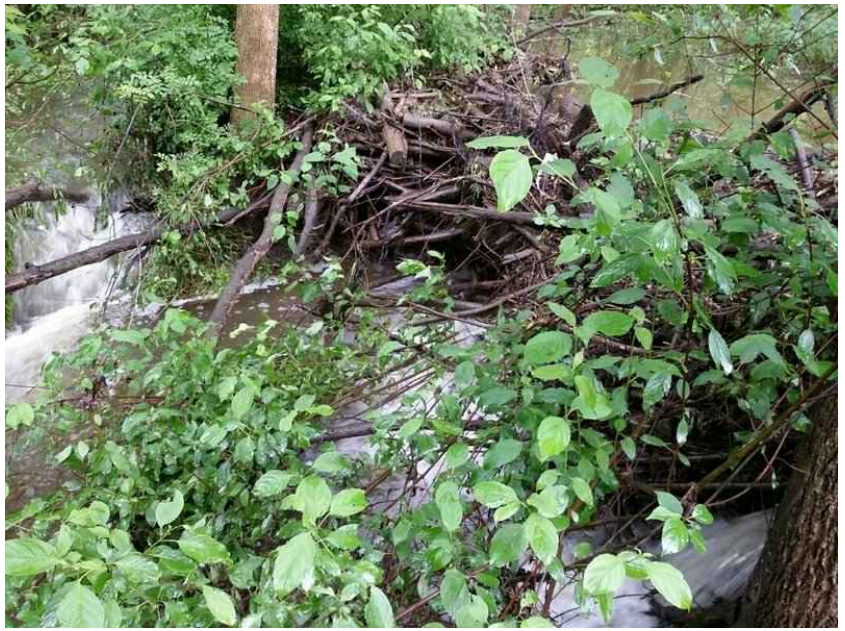
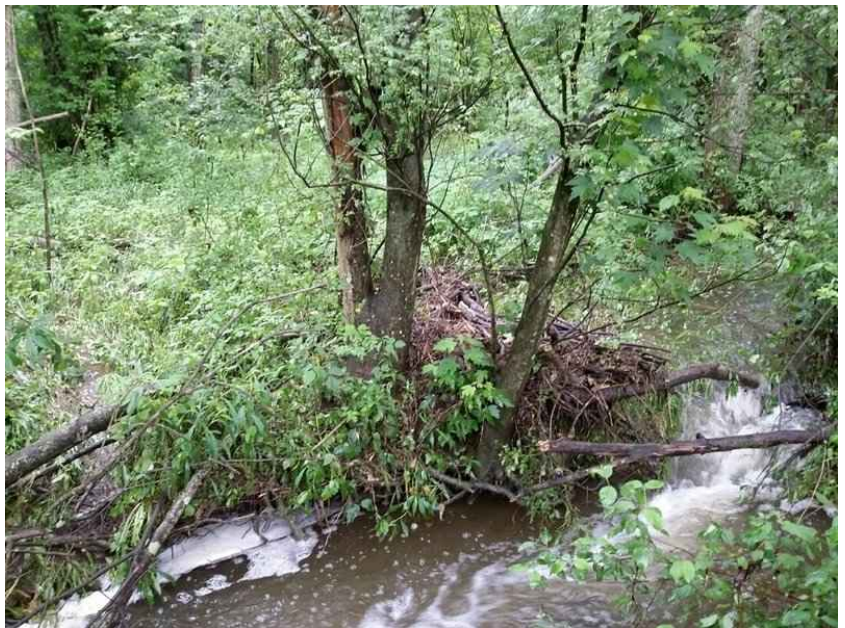
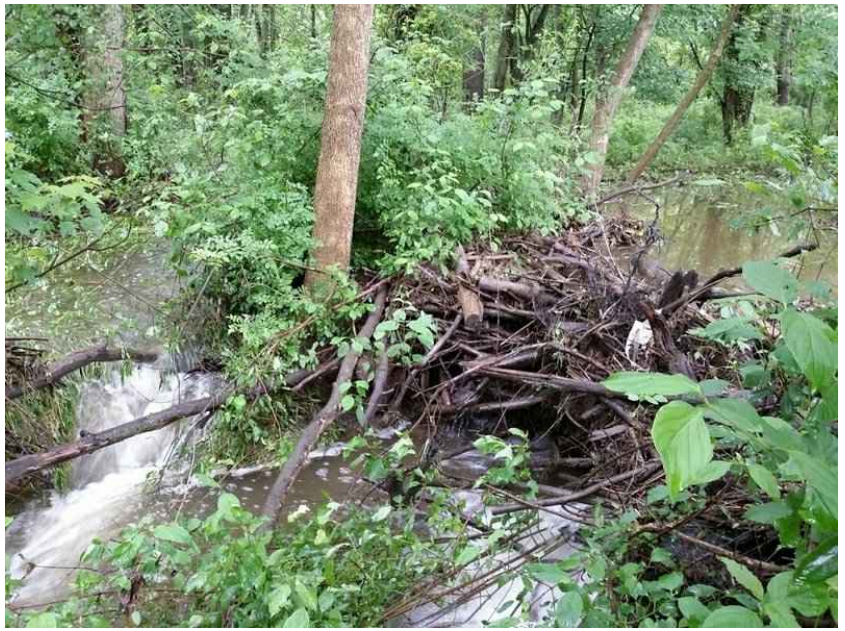
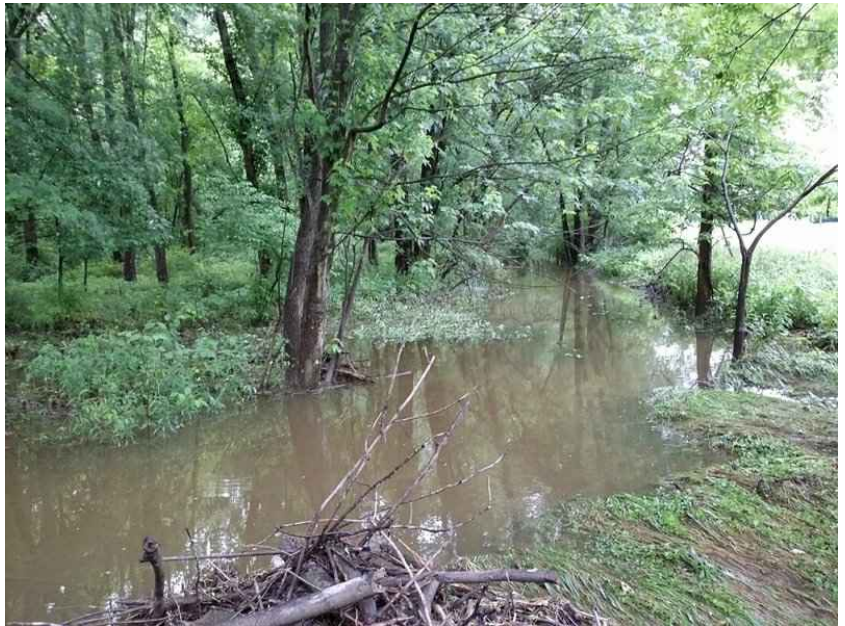
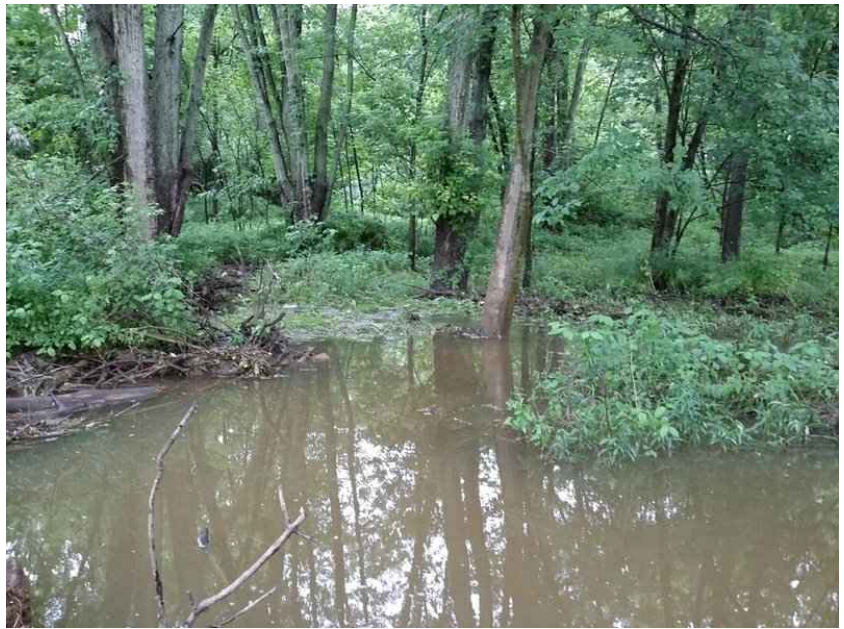
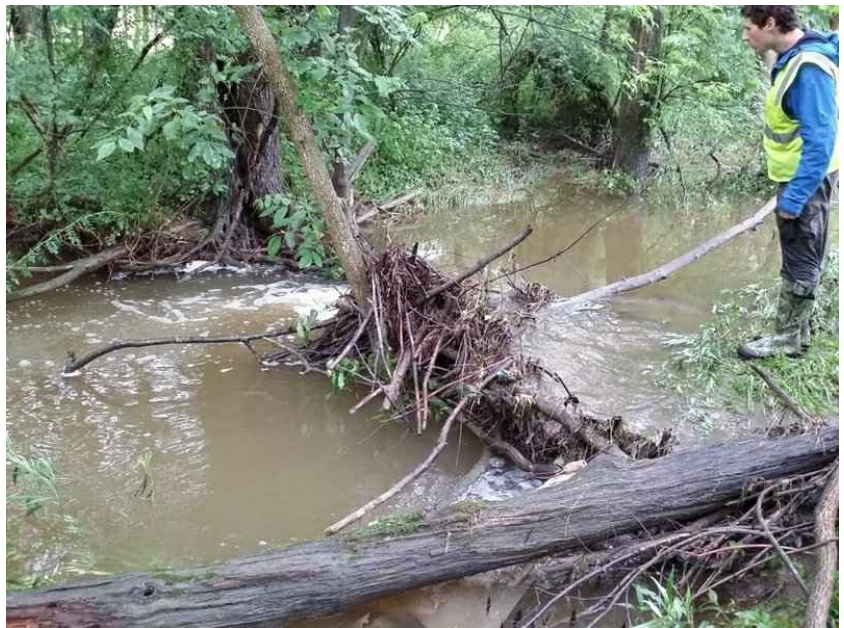
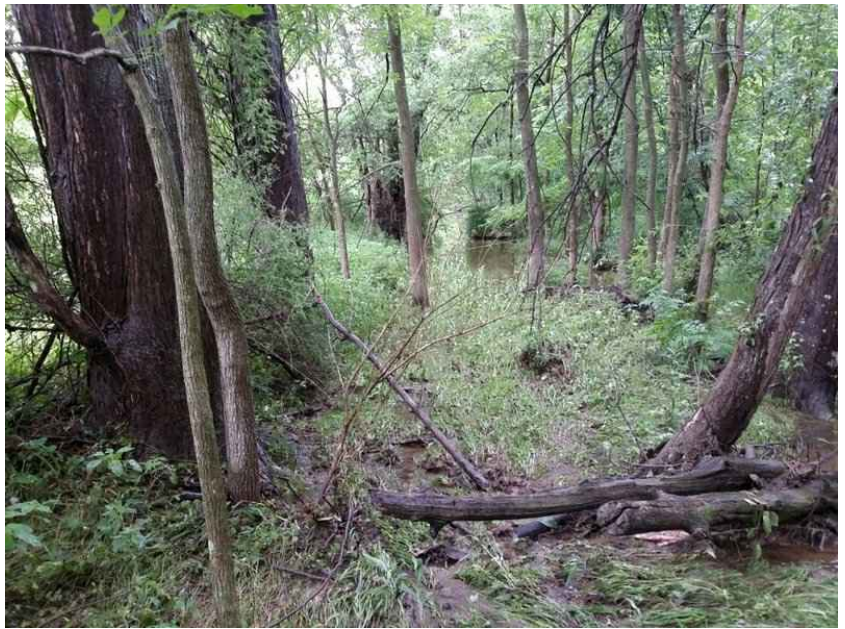
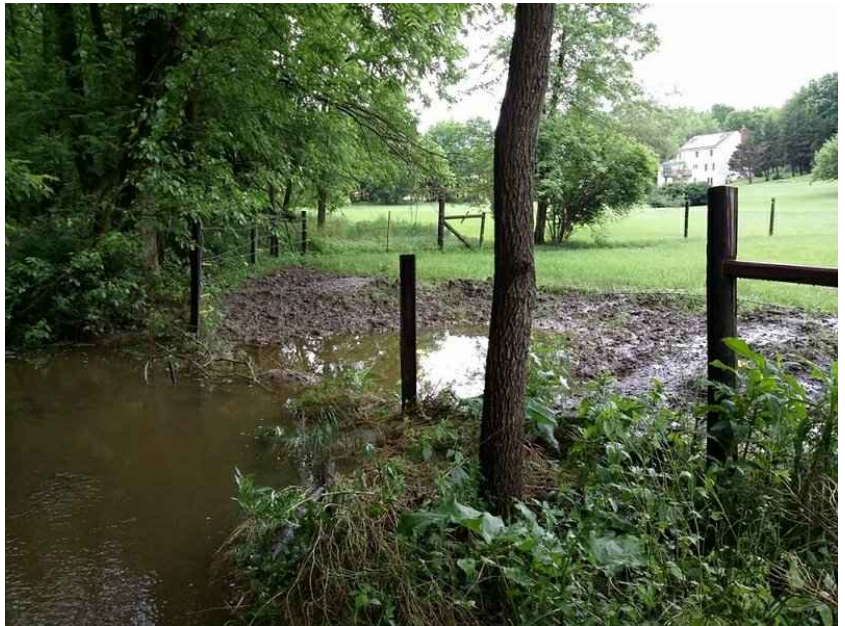
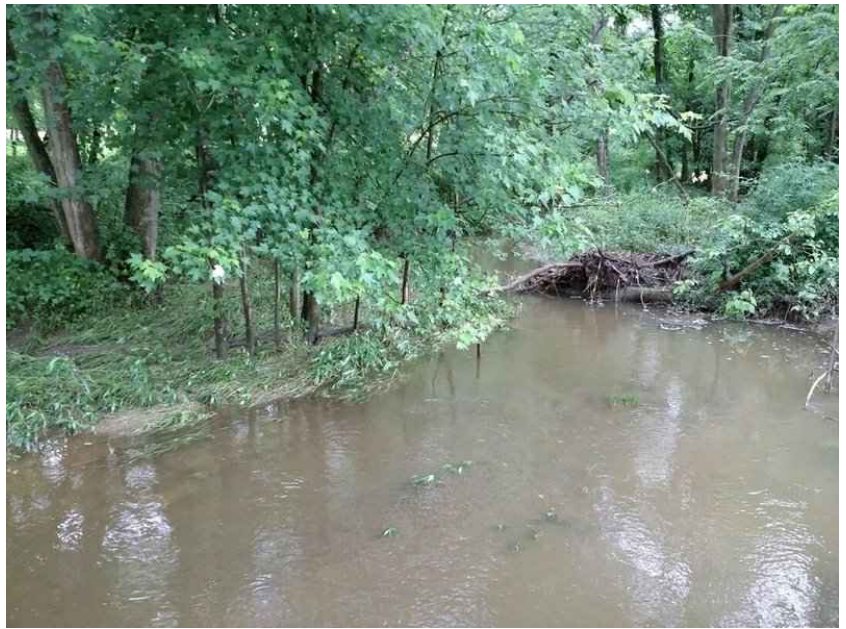
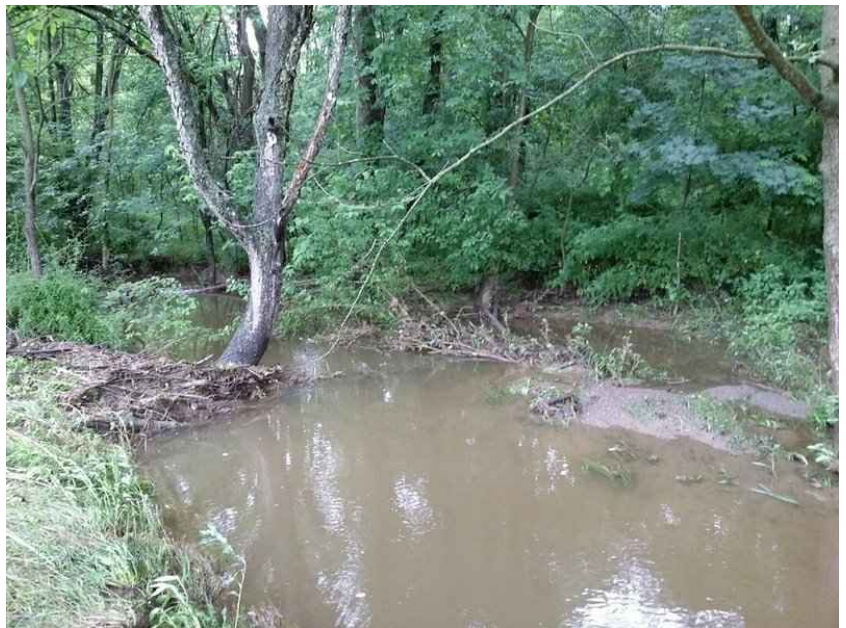
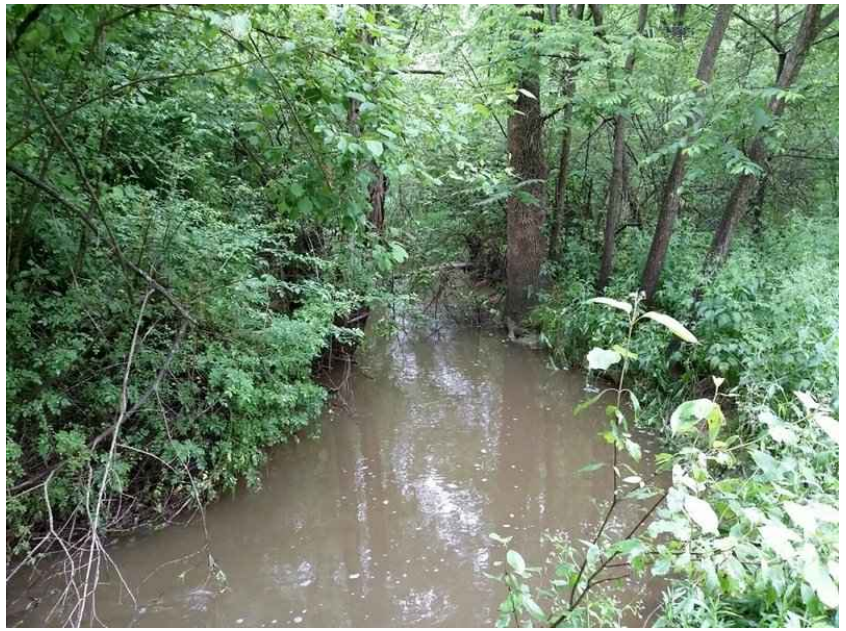
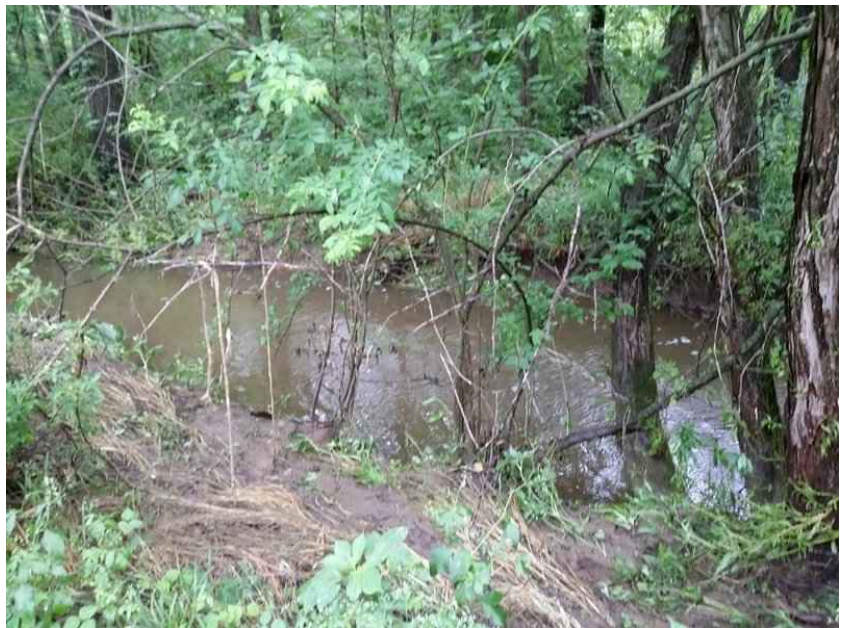
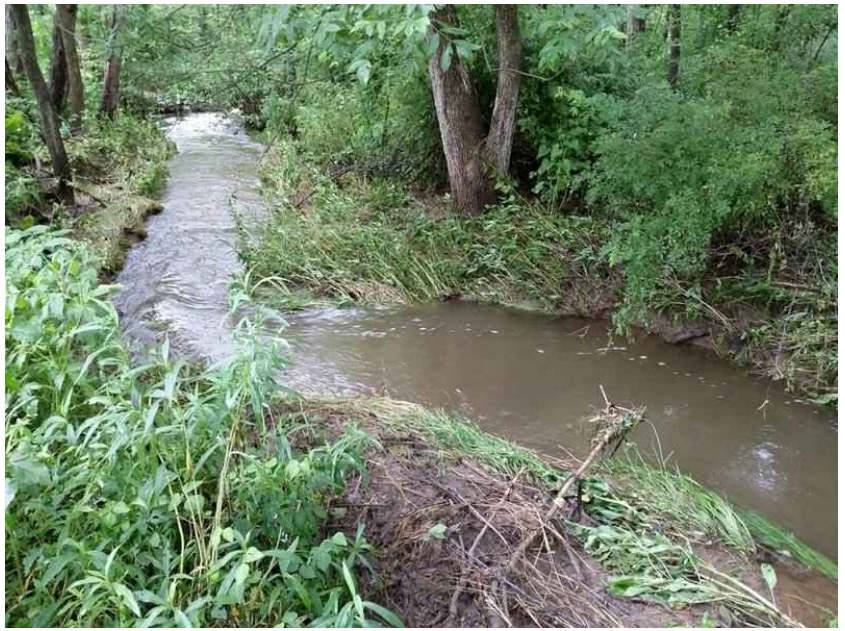
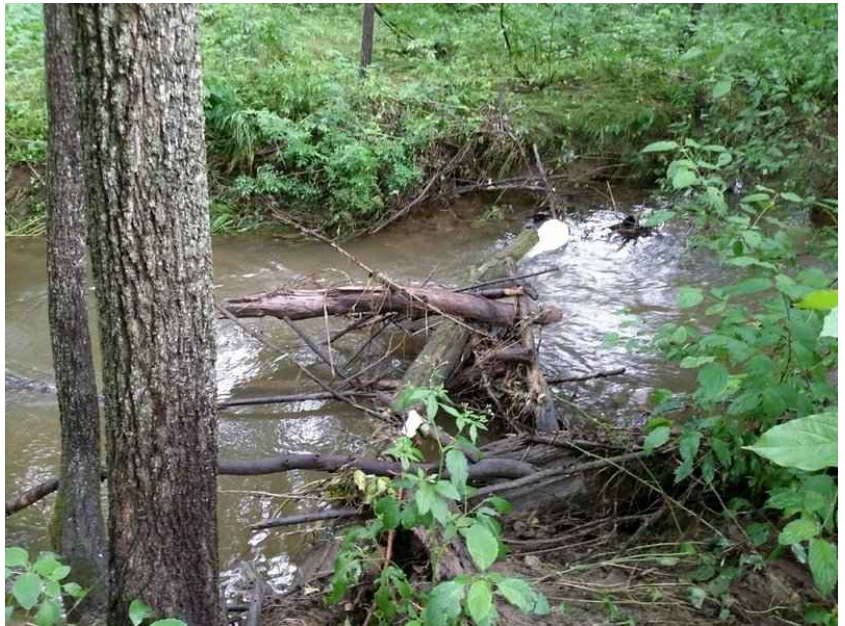
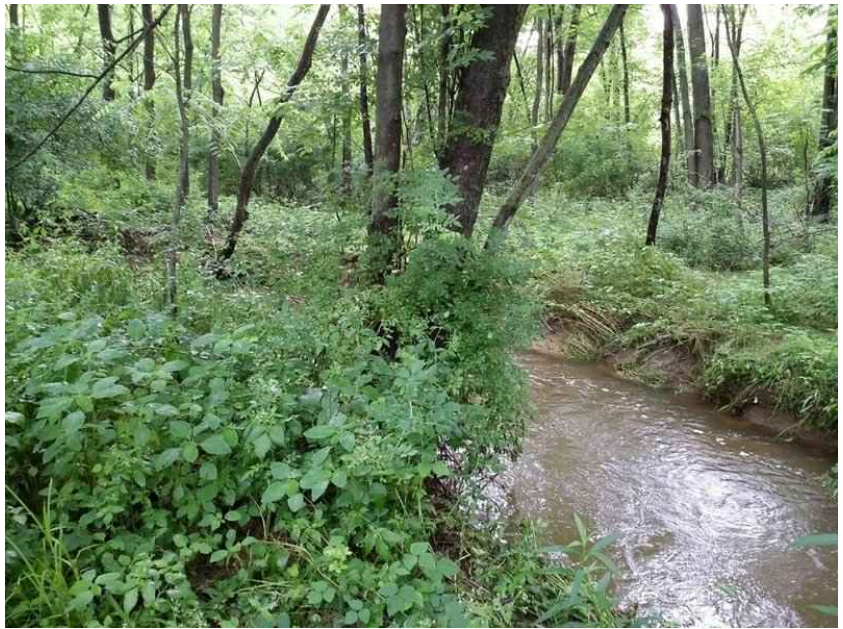
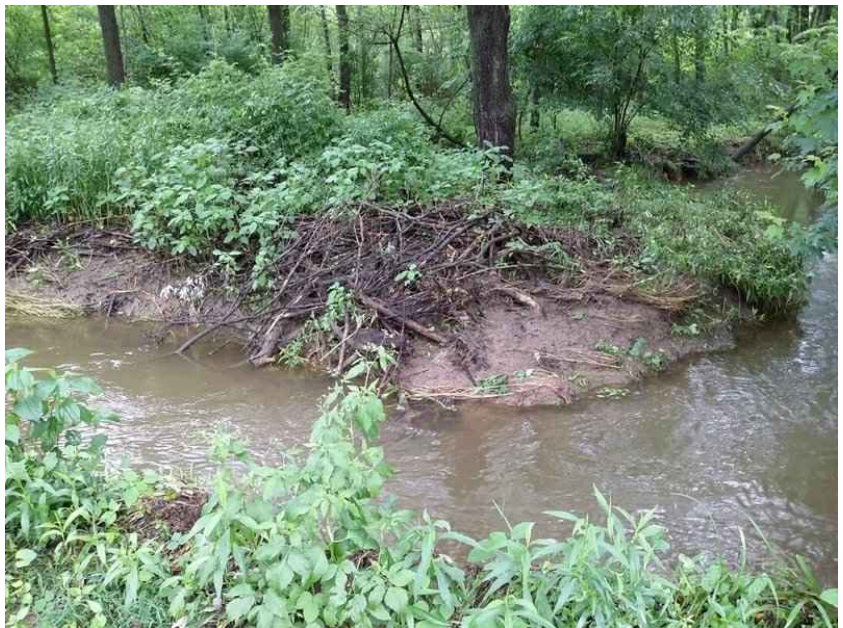
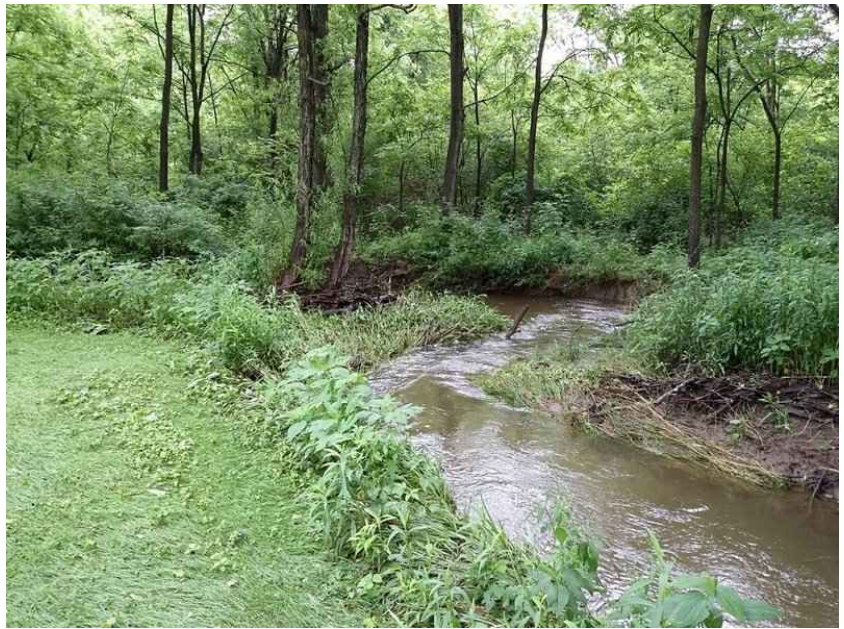
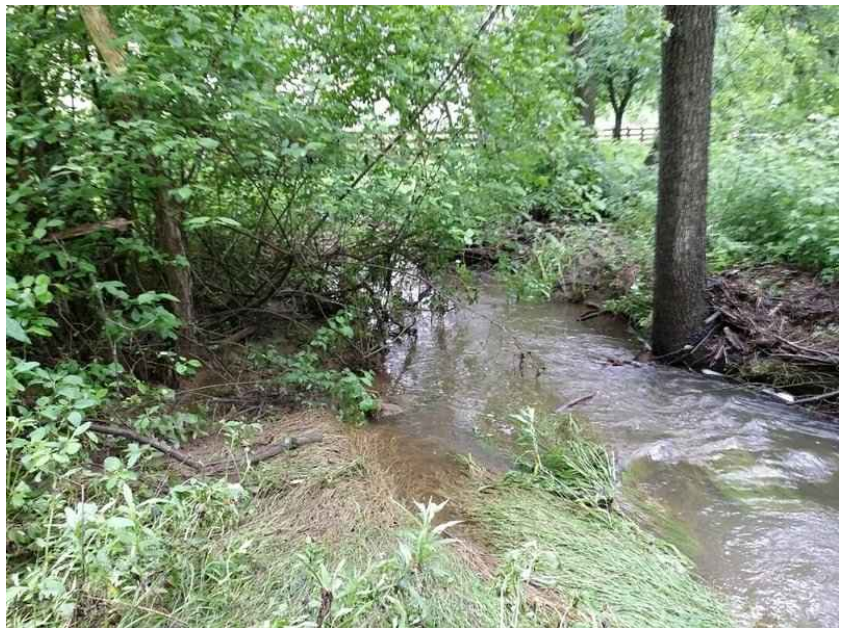
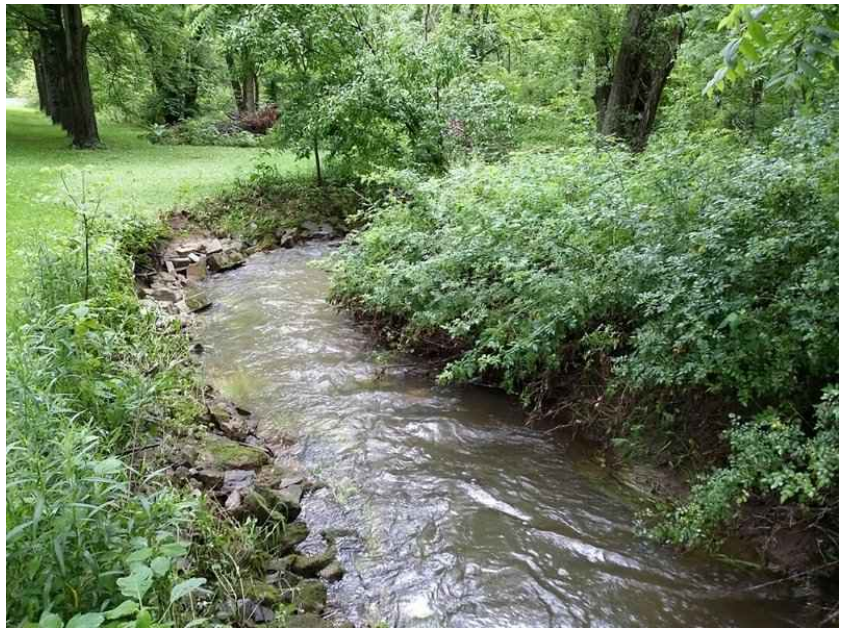
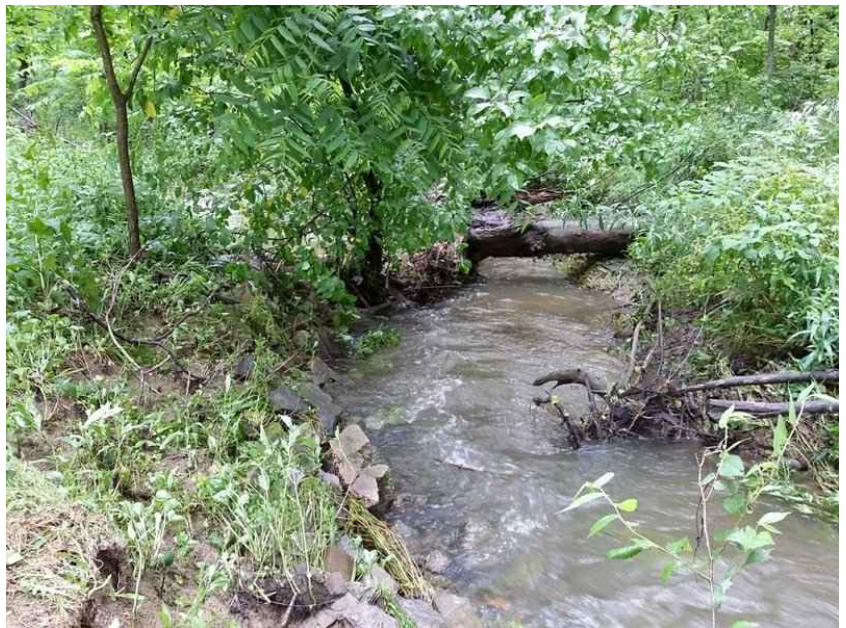
Photos

| Reach Setting | U/s, d/s dried bed- does not extent to property boundary |
| Vertical Adjustments Notes | Some sidebars - small in size Some nickpoints due to steep slopes. No serious headcut observed. Hay bales placed at some locations (to dissipate energy?) |
| Floodplains/Terraces Notes | No floodplain observed. More apparent where stream starts to flatten out. Channel bank slope continues same as upland slope |

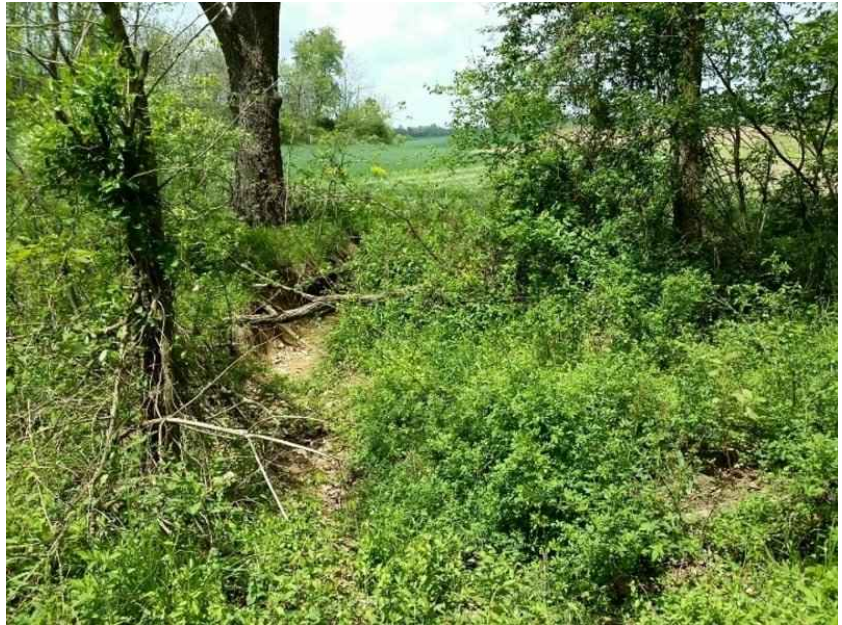
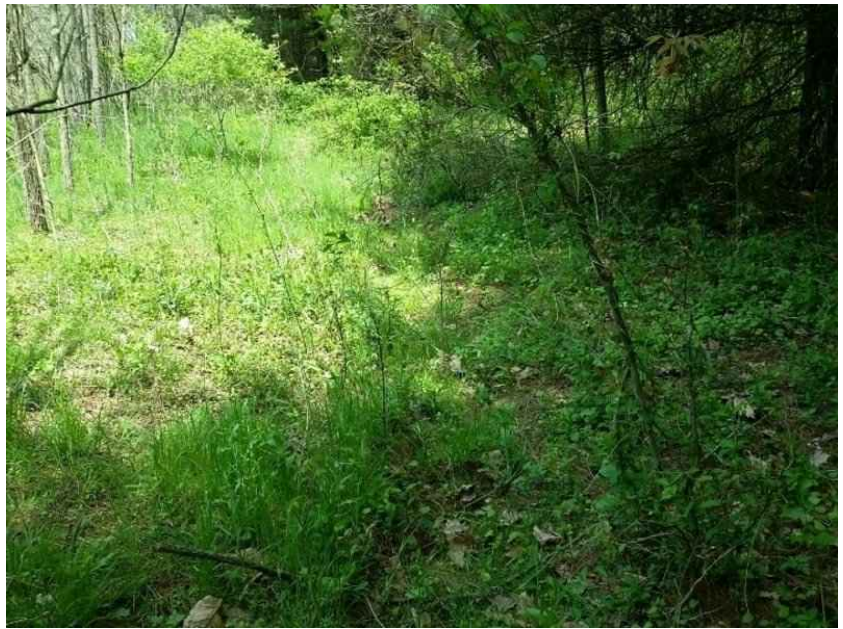
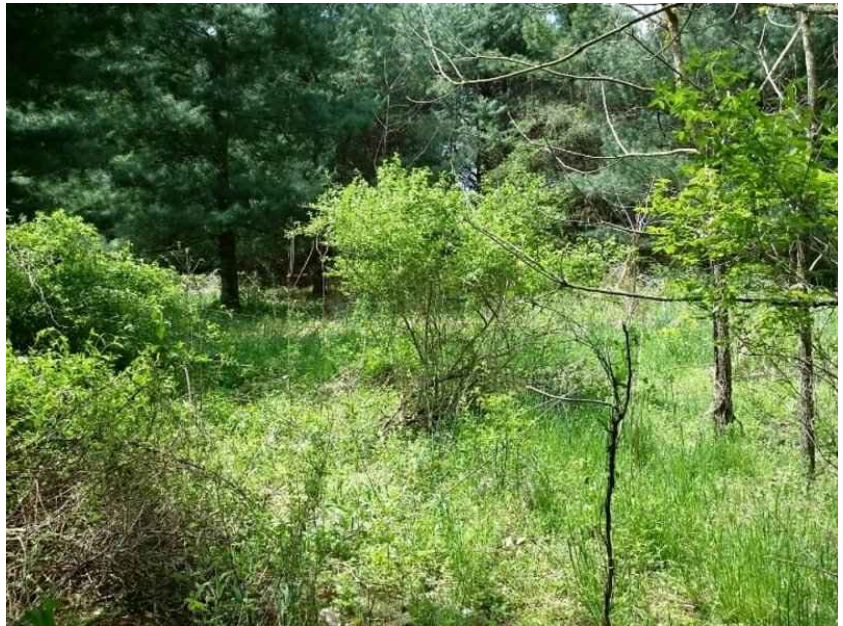
Photos

This area is the valley at the base of an old agricultural field. The downstream boundary is marked by a line of trees between fields. An incised but dry channel appears at this boundary (and appears to have a low point just downstream of the boundary), while upstream, in this reach, the channel is dry and the channel bed is at a higher elevation - it appears to have been filled in by sediment over the years. The ground was a little moist, but there was no standing water. Upland tree species, including tree of heaven, were present. Form filled out in office. Do not recommend as a restoration site.

| Restoration Ideas | None - the channel downstream of this reach appears to be in a similar condition to this one - an area where drainage from the old farm field collects, but does not continue downstream as surface flow. There does not appear to be an issue with erosion from surface runoff. No impervious area drains to this point, so a stormwater BMP would not be appropriate here. |
